**NTSB** National Transportation Safety Board

*Office of Research and Engineering*

# **Finite Element Analysis**

Carl R. Schultheisz

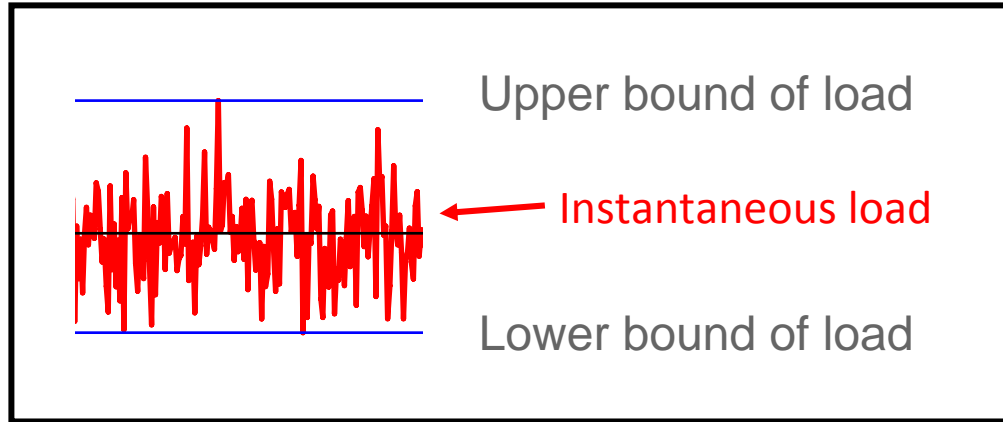
# Instantaneous Loads are Variable

Some of the many sources of variability  
at the time of the accident

- Traffic
  - Amount
  - Position
  - Motion
- Weather
  - Wind
  - Temperature
- Construction Activity
  - Amount
  - Position
  - Motion

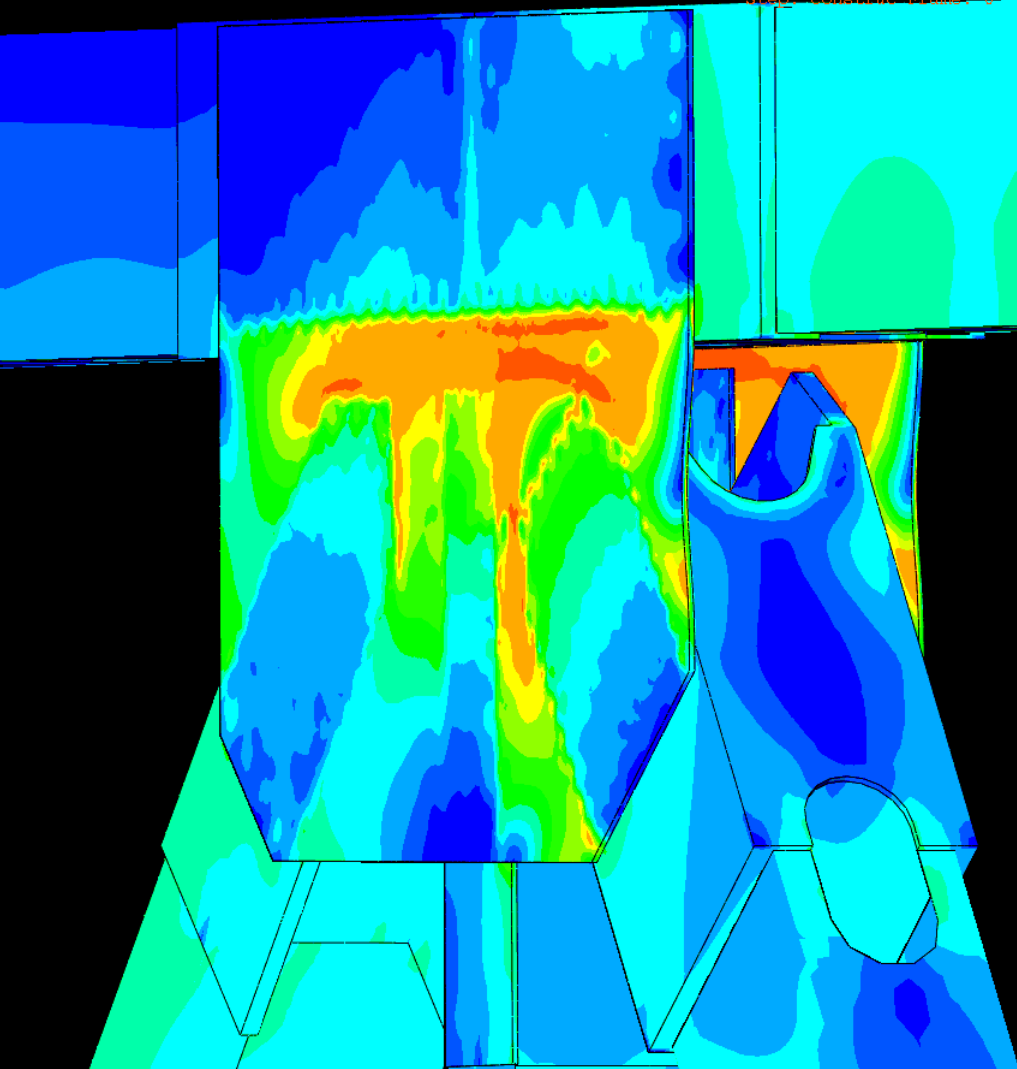
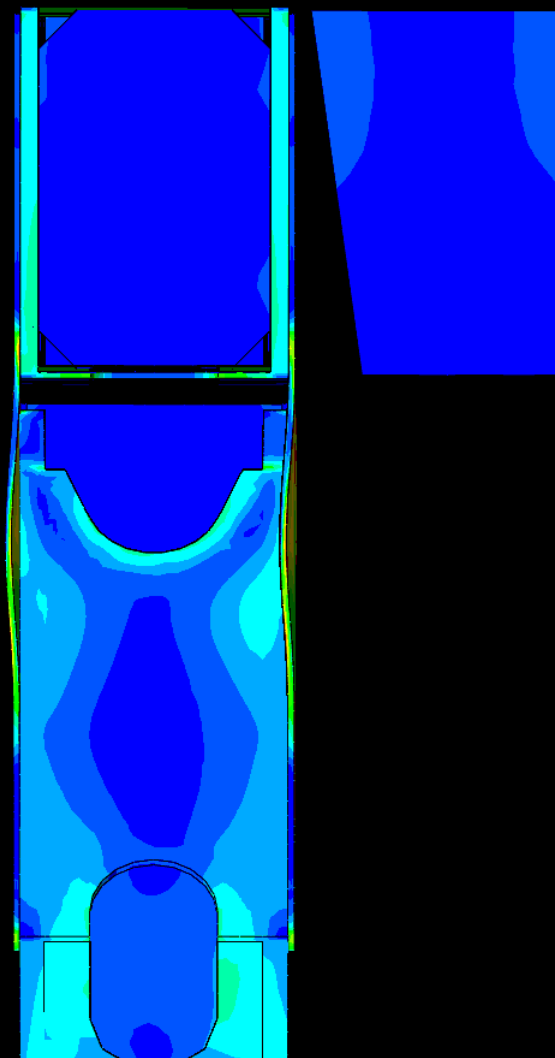
# Simulation – Failure Initiation

- Collapse began at node U10W when highly stressed gusset plates were unable to prevent unstable lateral shift of upper end of highly loaded compression diagonal
- Gusset plates meeting AASHTO specifications would have safely supported loads on bridge at time of accident
- Bowed gusset plates reduced load necessary to trigger instability and resulted in lateral shift to outside of bridge, consistent with physical observations

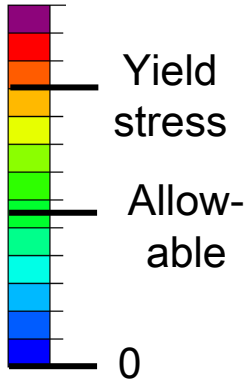
# U10 West and U10 East

Has higher stress  
at the time of the  
accident
